CONCRETE COLUMNS REINFORCED WITH ADVANCED COMPOSITE GRID STRUCTURES

A Thesis

Department of Civil and Environmental Engineering

Brigham Young University

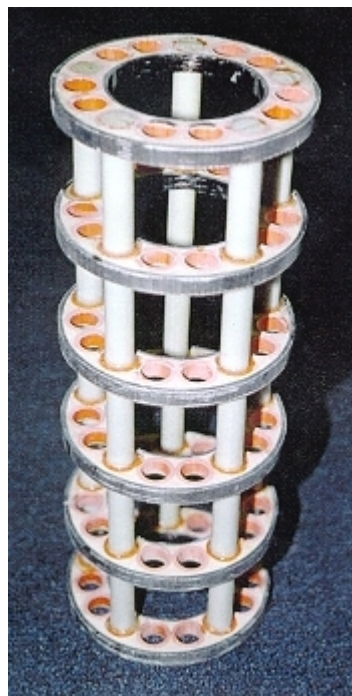
FIGURE 1 PHOTOGRAPH OF ADVANCED COMPOSITE GRID STRUCTURE

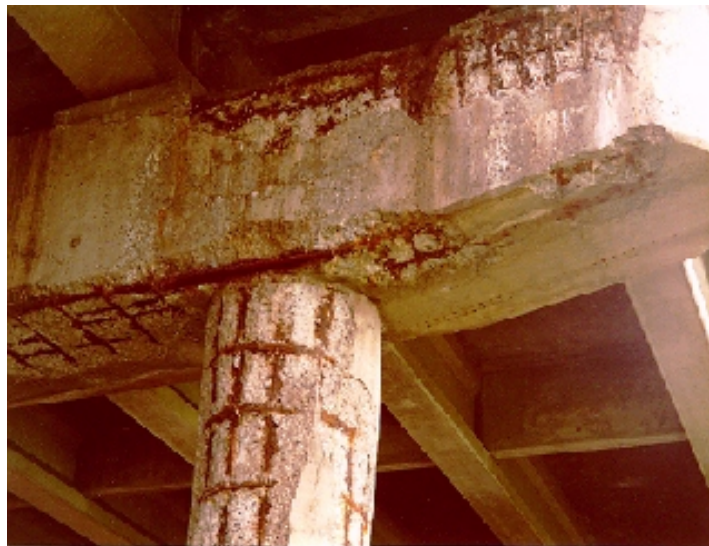
FIGURE 3 CORRODED CAP BEAM & COLUMN, HOOP & VERTICAL STEEL WEAKENED

Rapidly deteriorating infrastructure is reaching crisis proportions. Recent articles have iterated the problems of a decaying infrastructure, with nearly one quarter million bridges in the United States alone being structurally deficient [Dunker and Rabbat, 1995]. Although some of these deficiencies are due to ever-increasing traffic loads, a major cause is deterioration introduced by corrosion of reinforcing steel in concrete structures. Corrosion in reinforced concrete structures poses multiple problems. A porous material, concrete allows some fluids to penetrate. Water and alkalis penetrate the concrete and attack the steel reinforcement. Corrosion of the steel reinforcement causes the steel to expand. The forces caused by the expansion of the steel are enough to overcome the small tensile capacity of the concrete and cause the concrete to crack and spall. With failure of the concrete, the load transfer between the concrete and steel is lost and the reinforcement becomes useless (see Figure 3).

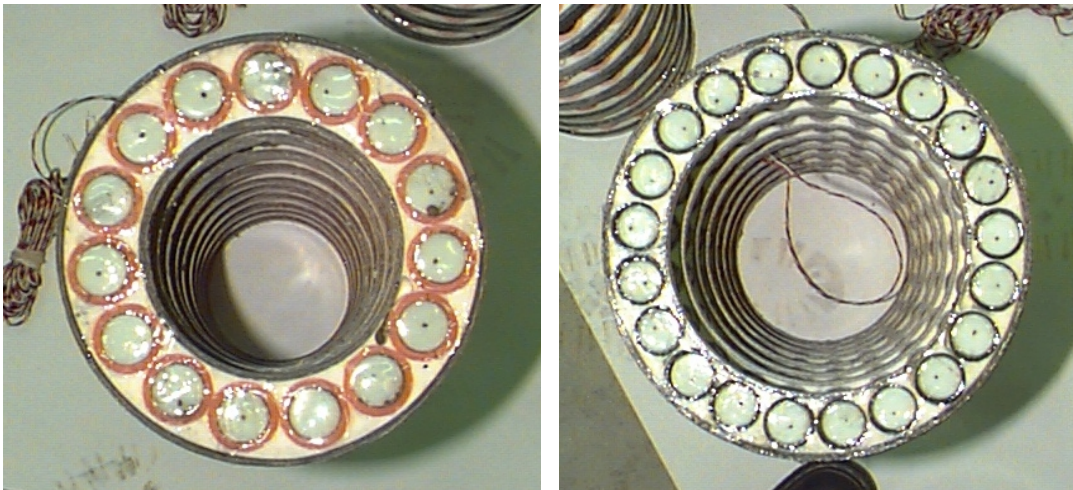
FIGURE 11 PHOTOGRAPH OF END CIRCS FOR 1ST AND 2ND GENERATION COLUMNS

The manufacturing process for these advanced composite grids utilize some of the most efficient processing techniques that are currently available: filament winding and pultrusion. The circs are composed of two hoop wound rings separated by extruded polymer tubes. The tubes are bonded to carbon fiber rings by vacuum infiltrated epoxy (see Figure 11).

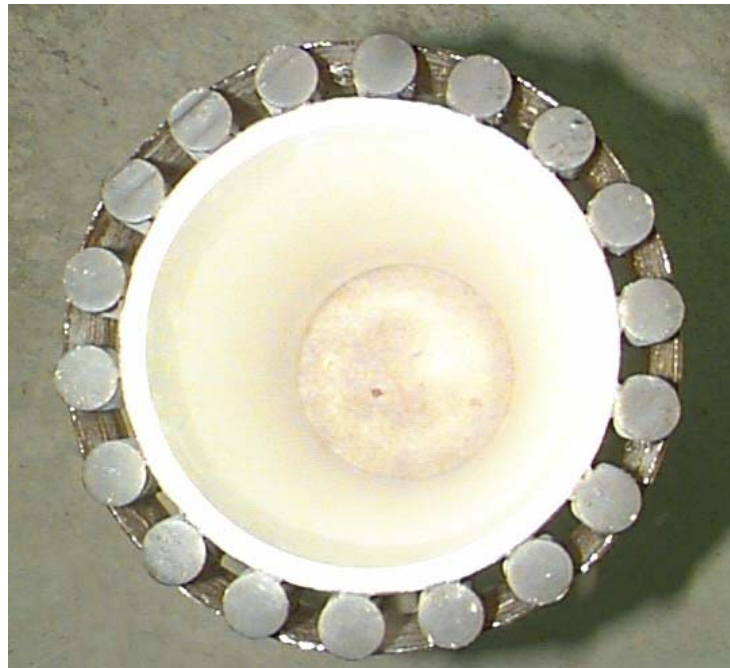
FIGURE 12 PHOTOGRAPH OF 3RD GENERATION COLUMN (ENDVIEW)

While the first and second generation columns were manufactured as a means for internal reinforcement, this 3rd generation of grid structure was manufactured with existing concrete columns in mind. A 15.3 cm (6 in.) diameter Polyvinyl Chloride (PVC) tube was used for a mandrel and two layers of Pittsburg Plate Glass, Mandeville Co. nominal tensile modulus (10.5×10^6 psi) strand fiberglass were wound around the PVC along the full length of the column. Before the resin cured, 18 longis were equally spaced around the column and the new grid was again wound on the filament winder (see Figure 12).

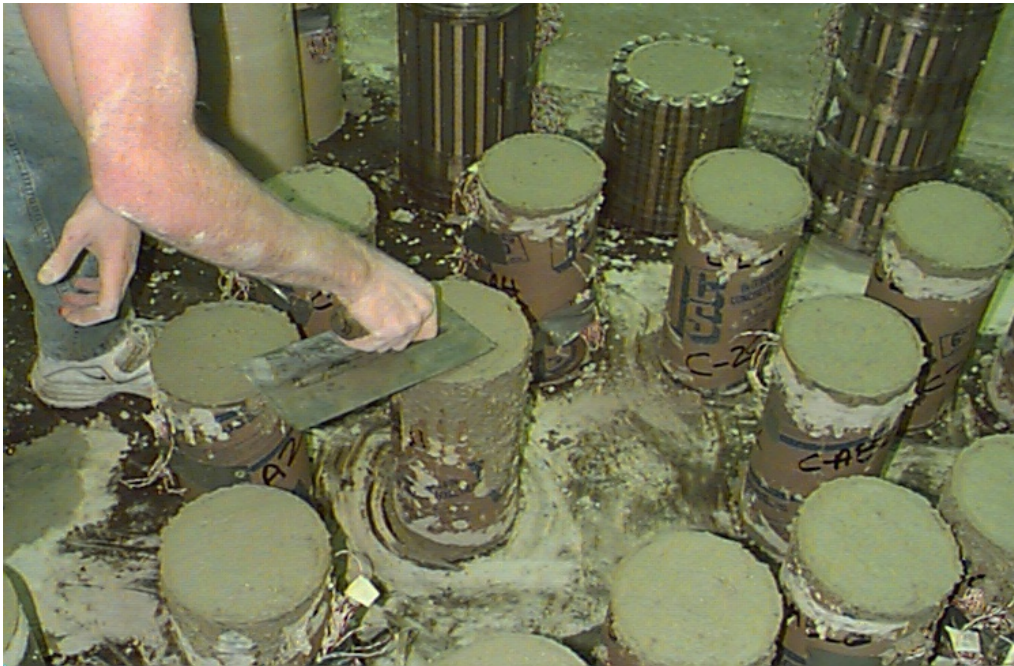
FIGURE 16 CONTROL SPECIMENS FOR 3RD GENERATION COLUMNS – 6 INCH DIAMETER

A 20.3 cm (8.0 in.) diameter by 45.7 cm (18 in.) long compression cylinder was poured with each set of 1st and 2nd generation columns (two sets). These sets or batches of the same mix design were required because of the limited capacity of the portable mixer. These full-scale specimens were used as control specimens in order to compare failure modes and compression strengths. The third generation column used smaller 15.2 cm (6 in.) control specimens to determine the compression strength of the mix design. Similar to the other columns, these control specimens were filled in five lifts of equal height and each lift was rodded 50 times. These samples were tested at the same time as the composite grid reinforced columns in order to determine the concrete strength at the time of testing (see Figure 16).

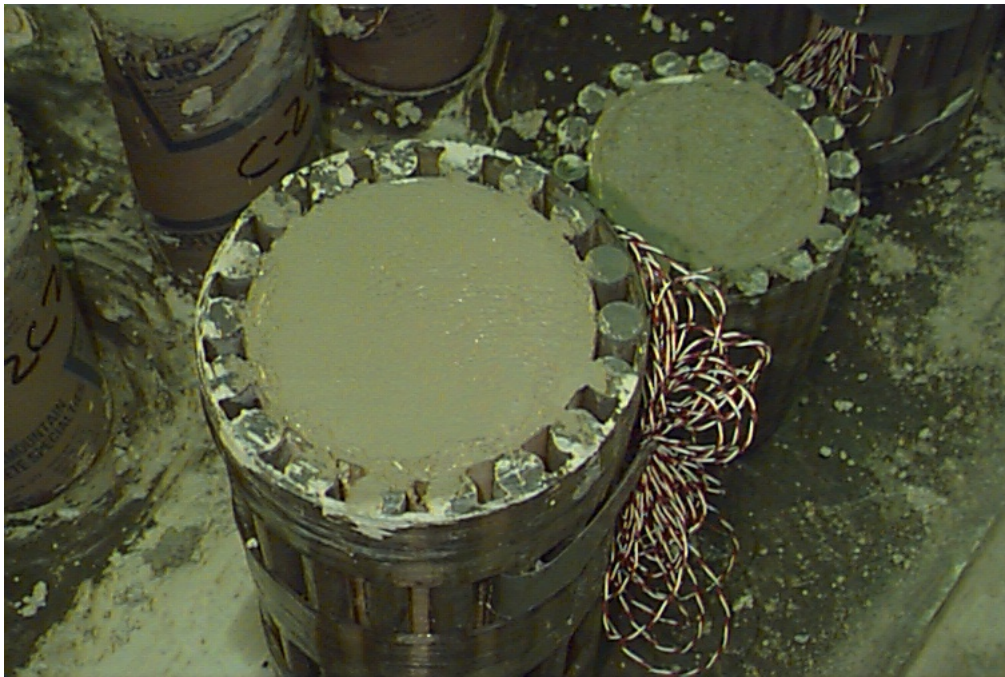
FIGURE 17 3RD GENERATION OLUMNS AFTER BEING POUED

The 1st and 2nd generation columns as well as the control specimens were left in the sono-tube molds overnight. The next day the sono-tube mold was removed from the columns and the concrete specimens were placed in the fog room where the temperature was maintained at approximately 23.9 °C (75 °F) and 90-95% humidity. The 1st and 2nd generation columns cured in the fog room for 28 days, while the the 3rd generation columns cured for only 7 days due to the different type of Portland cement used in the mix design (see Figure 17).

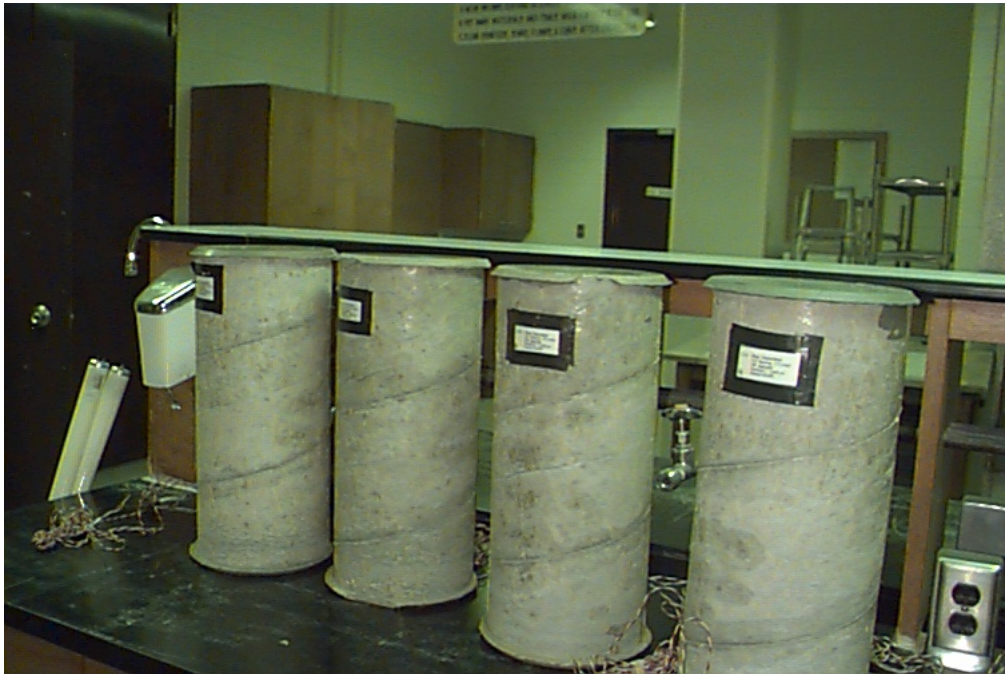
FIGURE 19 PHOTOGRAPH OF 1ST GENERATION COLUMNS WITH SULFUR ENDCAPS

After the concrete columns had been allowed to cure, they were capped using a sulfur compound. A sulfur cap ensures that the load will be distributed over the entire end of the column. This was important considering the configuration of composite reinforcement. Sulfur compound is commonly available as a powder or solid “chips” that must be heated over 250 °F before it will melt into a liquid. Once in liquid form, the sulfur is poured into a mold, and the concrete specimen is placed on top of the mold (see Figure 19).

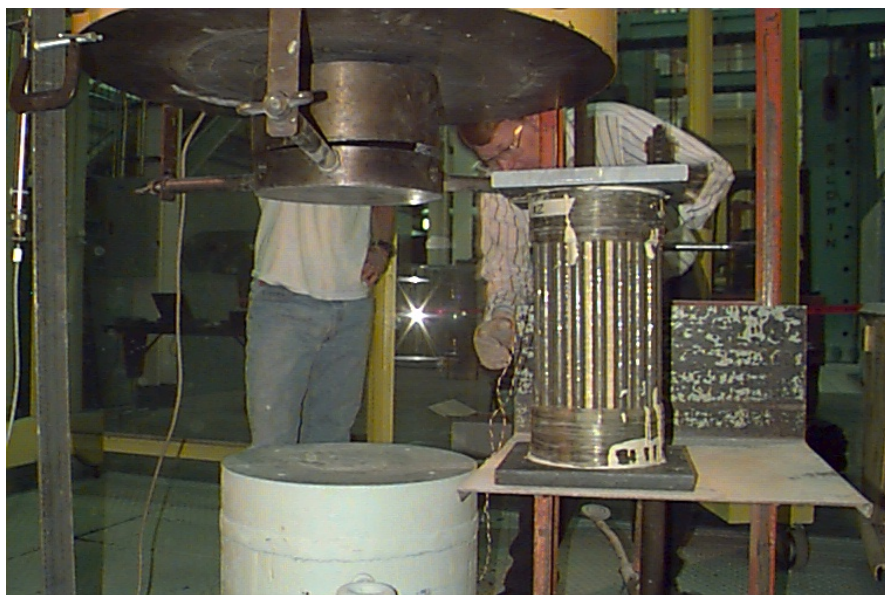
FIGURE 21 3RD GENERATION COLUMN WITH STEEL ENDCAPS

Because of this end failure, steel endcaps were also designed and manufactured for use with the 3rd generation columns (see Figure 21). These endcaps prevented brooming of the longis and had a significant effect on the overall strength and failure mode as discussed in Chapter 6.

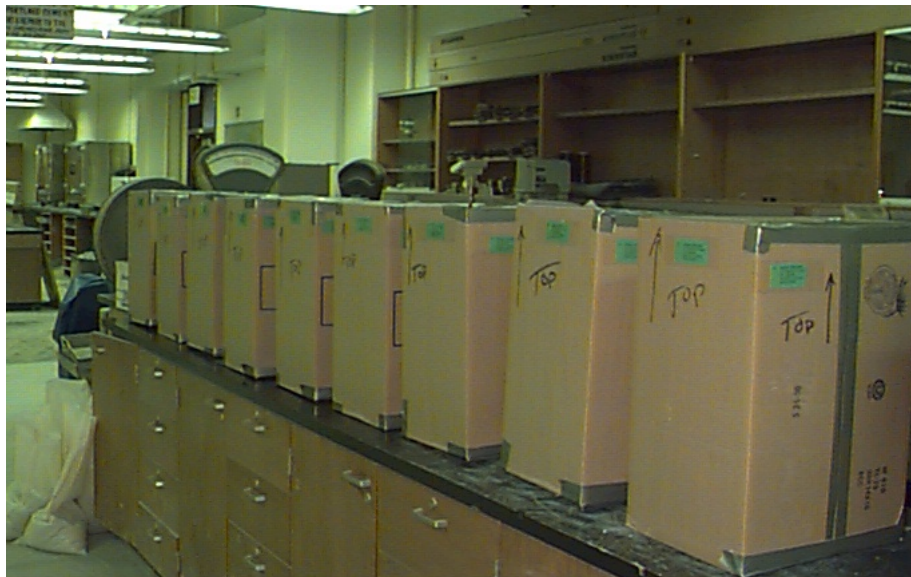
FIGURE 22 1ST AND 2ND GENERATION COLUMNS PACKAGED FOR TRANSPORT

After removal from the fog room, the concrete columns were allowed to dry until the surface was free of excess moisture. Strain gages were checked with the strain indicator box and marked with colored tape to identify leads to longitudinal and circumferential strain gages. Each column was then identified with a tag and packaged in 25 by 30 by 56 cm (10" by 12" by 22") cardboard boxes for the 500 mile trip to Denver, Colorado (see Figure 22). Wet papertowels were wrapped around the columns to keep them moist and foam packaging was used to protect the endcaps on the columns during transport.

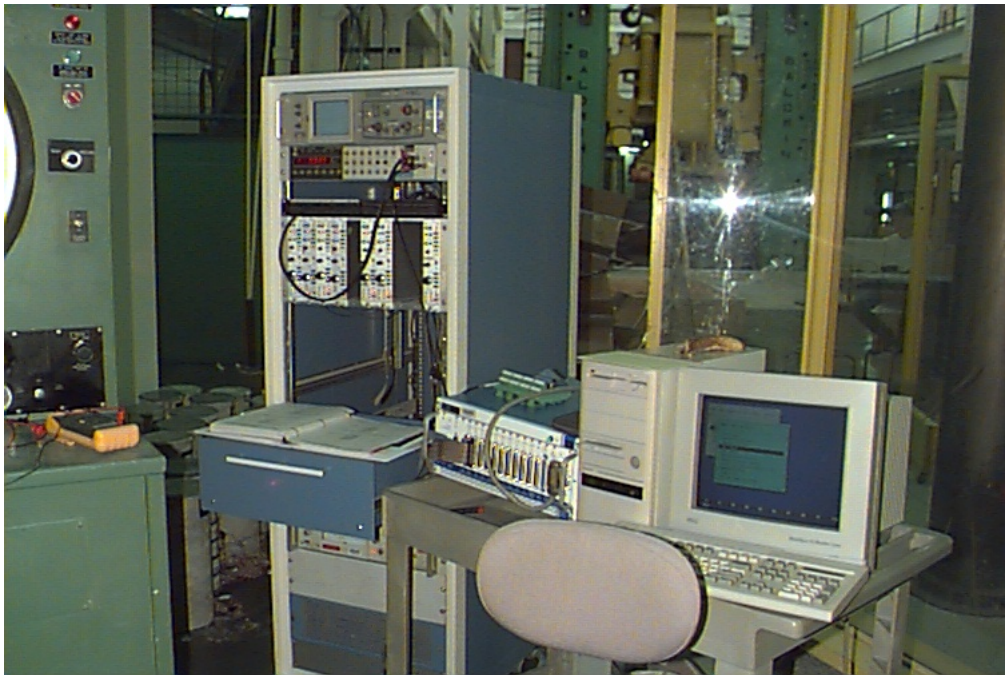
FIGURE 23 PHOTOGRAPH OF MEGADECK® DATA ACQUISITION SYSTEM

For preliminary tests at Brigham Young University, data was acquired on a Compaq® Deskpro XL 566 with an Adaptec® 154CF SCSI Controller. This controller used an HPIB interface to communicate with a NEFF® 470 system containing twelve 4-channel bridge conditioning cards for strain gage and load cell data and one 16-channel differential input card for measuring changes in DC voltage inputs. The system employed Autonet 4.11® operating system. For compression tests conducted on all other grid structures, data was acquired on a portable Optim Electronics Megadeck® 5414AC with a 16-bit analog digital converter (see Figure 23).

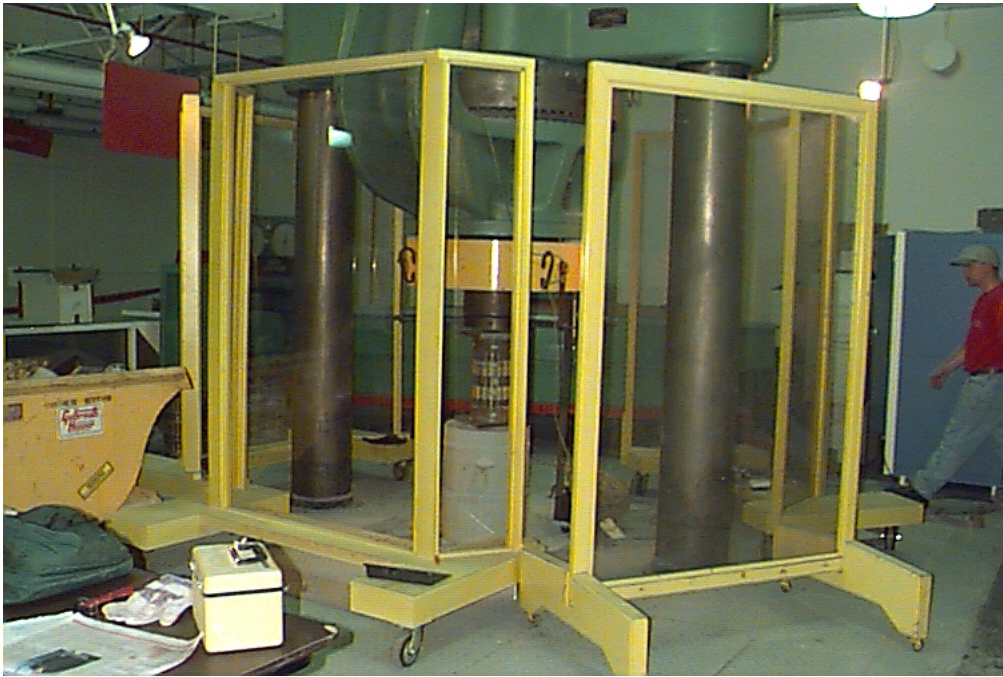
FIGURE 24 PLEXI-GLASS SHIELDS USED FOR PROTECTION DURING TESTING

Because these systems were portable, the distance between the data acquisition system and the test specimen was less than 6 m (20 ft.). This allowed the instrument leads to be relatively short. Thus, a two-wire scheme was used to simplify connection of the strain gages. Because of the high compression load sustained by the columns during testing, the data acquisition system and personnel were protected by plexi-glass shields (see Figure 24). These shields proved to be vital for safety during testing due to the explosive nature of the outer layer of concrete on the columns during failure.

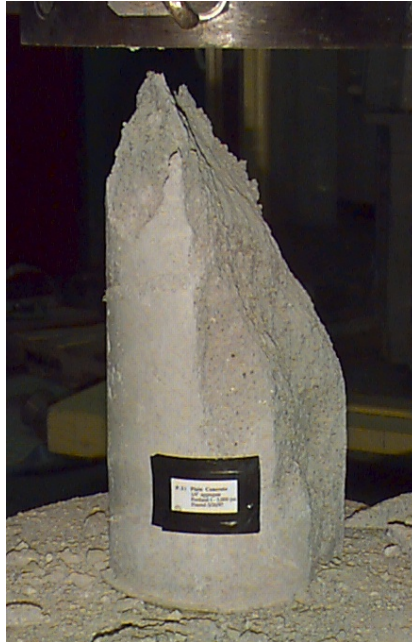
FIGURE 25 PHOTOGRAPH OF CONTROL SPECIMEN AFTER FAILURE

determine the compressive strength of the concrete mix design for the 1st and 2nd generation (see Figure 25)

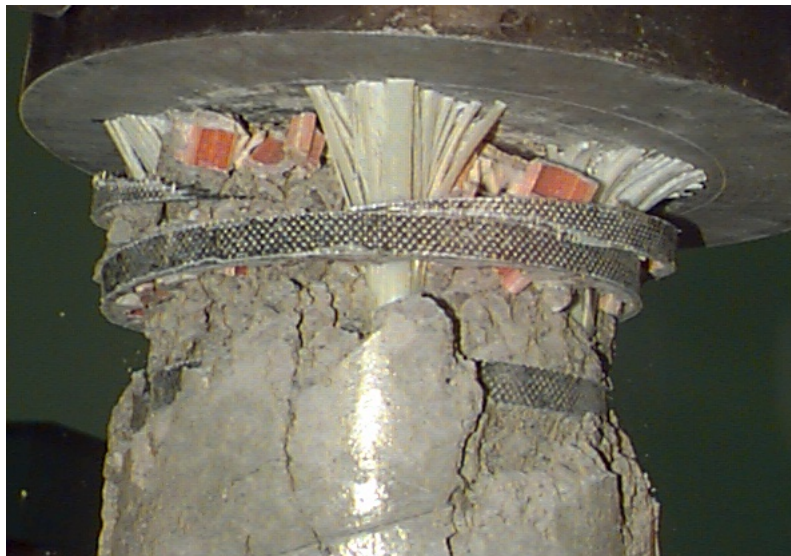
FIGURE 26 PHOTOGRAPH OF TYPICAL END FAILURE FOR 1ST GENERATION COLUMN

In the advanced composite grid reinforced concrete columns, failure generally initiated at one end of the column instead of the typical shear failure mode. The concrete crumbled locally, the end circ slid down the longis and the ends of the pultruded longis exhibited brooming (see Figure 26).

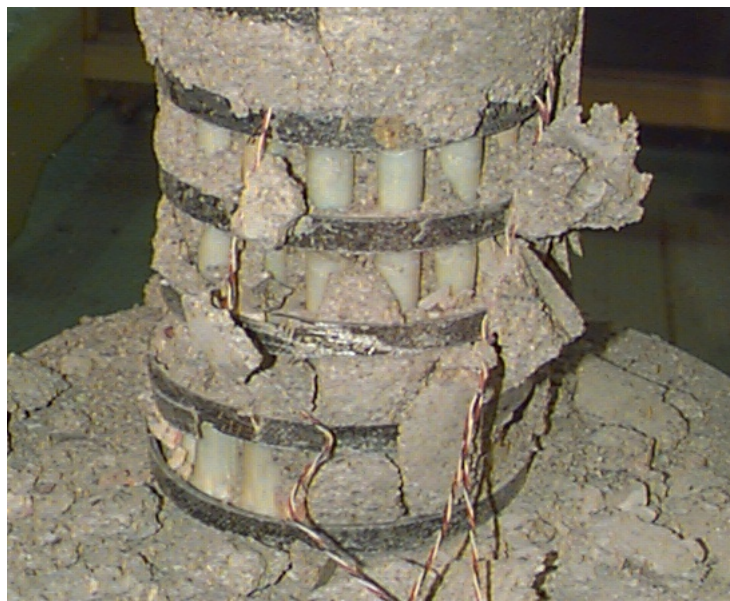
FIGURE 27 CONTINUATION OF END FAILURE FOR 1ST GENERATION

Eventually the end circ would fail dramatically, sending the crumbling concrete flying away from the column, allowing further bending and brooming of the longis. At this point, the load on the column dropped by 1/3 to 1/2 and then slowly climbed back up to approximately the original maximum load level, and another circ would fail in a similar manner (see Figure 27). The second generation columns demonstrated similar behavior during failure but at a much higher load. Once two or three of these circs had failed the sustained compressive load would decrease significantly and the test was stopped.

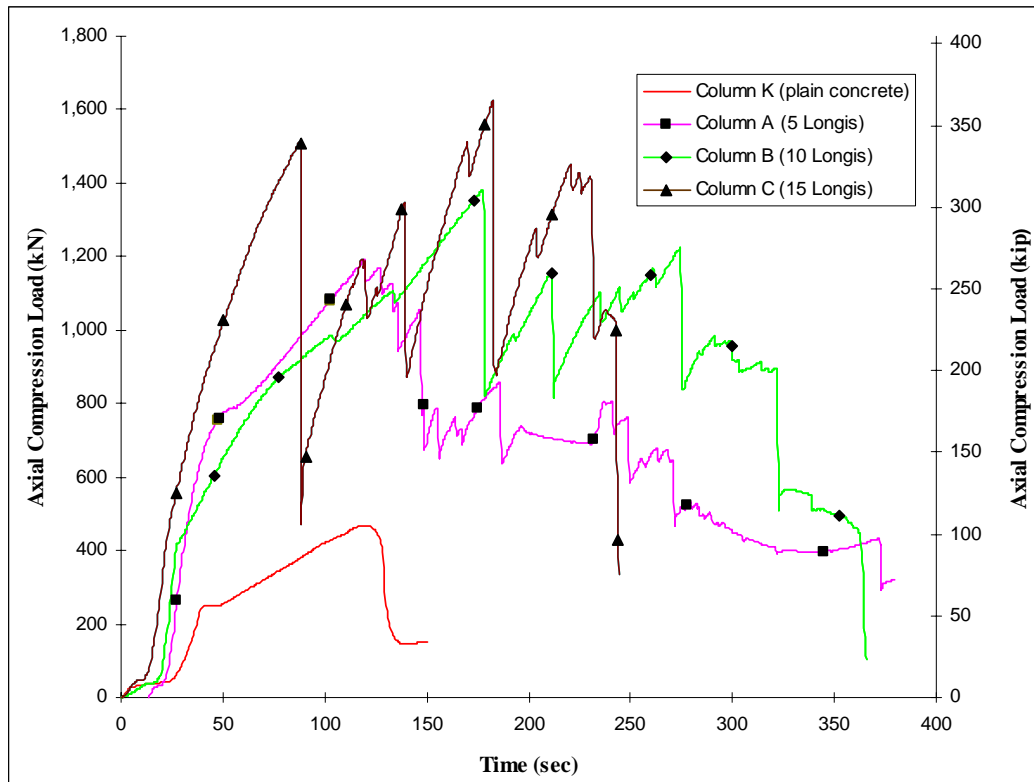
**FIGURE 28** LOAD VS TIME FOR 1ST GENERATION COLUMNS WITH 5.1 CM (2.0 IN.) SPACING

One of the most fascinating results from this research comes from load data recorded over time as the columns failed in compression. Because the load is controlled by the stroke of the compression machine, the load vs time graph can not be used to directly compare the columns. However, a comparison of load vs time shows how individual columns were affected as each circ failed (see Figure 28).

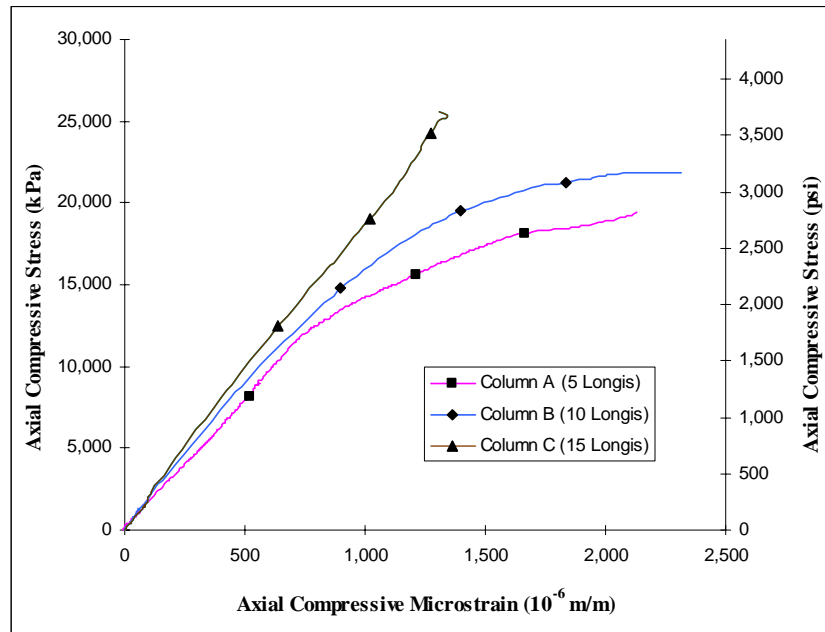
FIGURE 29 AXIAL STRESS VERSUS STRAIN FOR 5.1 CM SPACED 1ST GENERATION

Although the strength of the individual columns was not affected a great deal by the number of longis, the load defelction curves were. The initial slope of the stress-strain curve is affected by properties of the fiberglass rods which are much stiffer than concrete (see Figure 29).

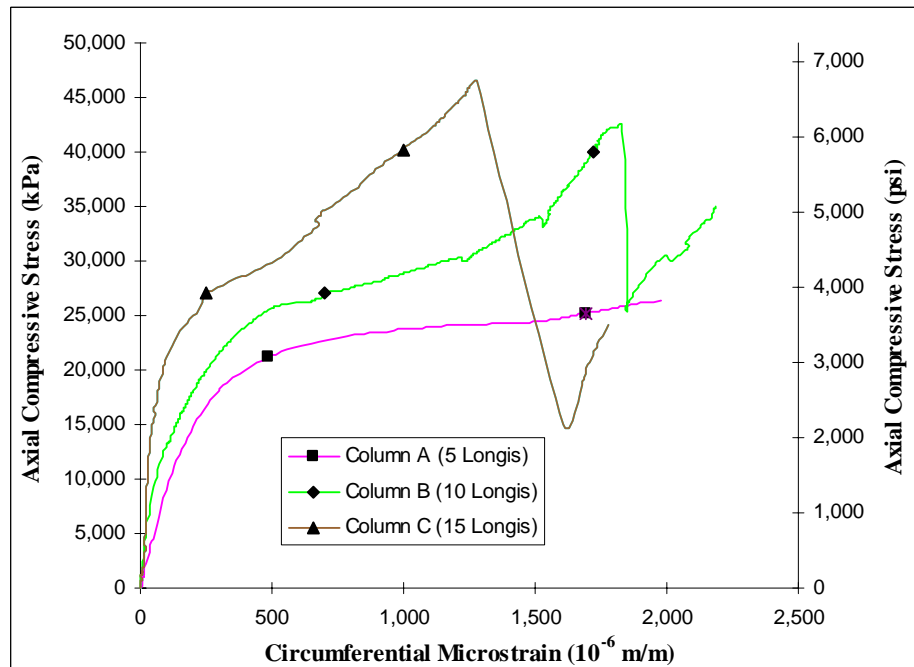
FIGURE 30 CIRCUMFERENTIAL STRESS VERSUS STRAIN FOR 5.1 CM SPACED 1ST GENERATION

This effect upon stress-strain curves in longitudinal reinforcement is also seen in the stress-strain relationship for the circumferential reinforcement (see Figure 30).

Figure 30 shows that the initial slope of the stress-strain diagram for the circumferential reinforcement of the column is affected by the number of longis resisting flexure. As the first circ failed, the stress dropped dramatically and the strain increased for the remaining circs in the column. Typically, one would expect the strain to decrease as the stress dropped; however, this occurrence is likely due to the stroke control of the compression machine, coupled with the radial expansion of the columns.

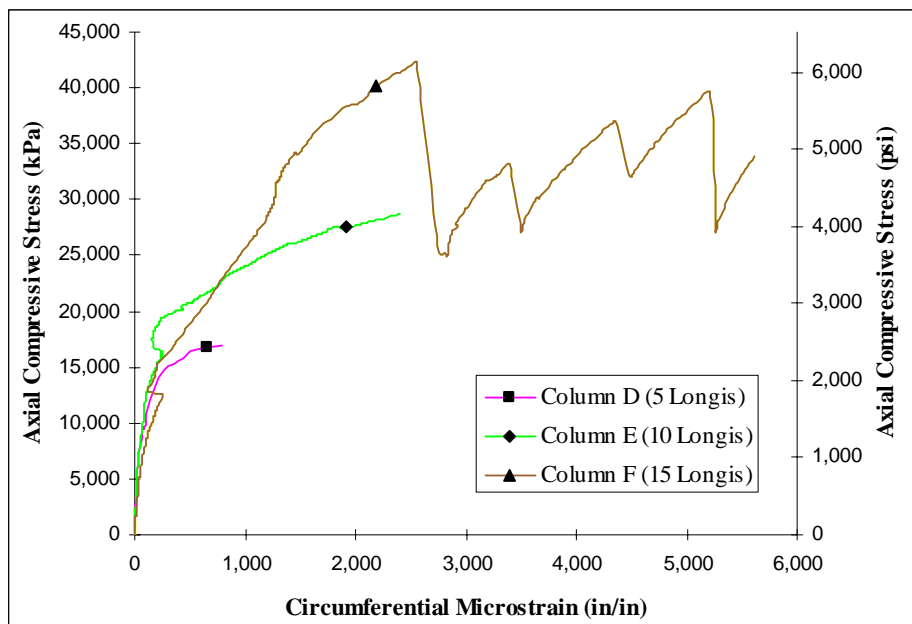
FIGURE 31 CIRCUMFERENTIAL STRESS VERSUS STRAIN FOR 10.2 CM SPACED 1ST GENERATION

The number of longitudinal reinforcement bars in the 10.2 cm (4.0 in.) spaced columns had a fair impact on the stress-strain curves. Most of the gages inside of the first generation columns failed to function very long due to an increase in strain after the first circ failed. However, Column F in Figure 32 shows the load transfer on a middle circ as several end circs failed in succession.

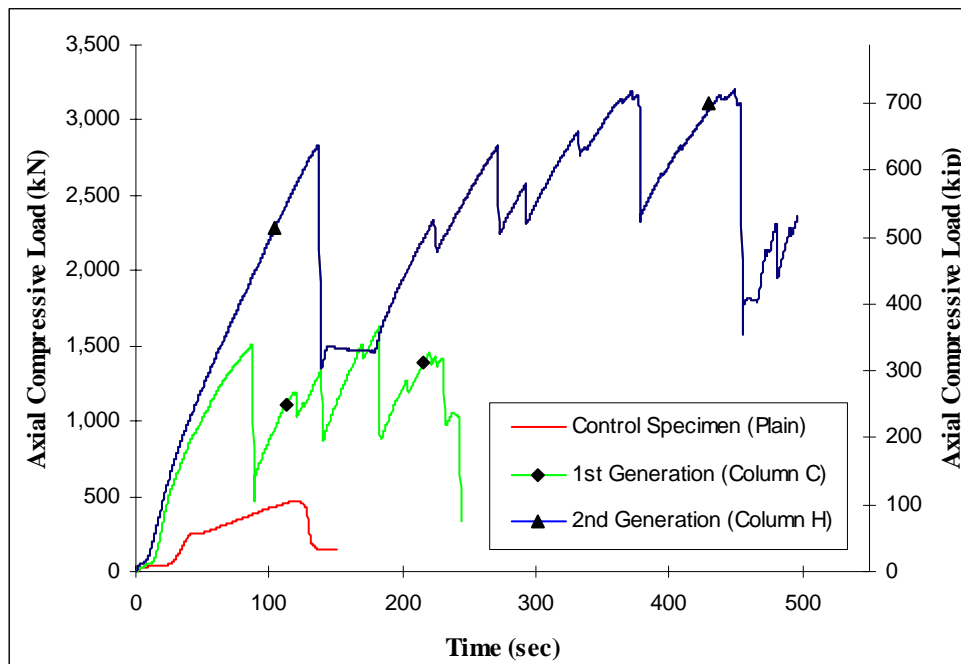
FIGURE 33 LOAD-TIME HISTORY SHOWING LOAD TRANSFER DUE TO CIRC FAILURE

These columns were averaging around 3.15 MN (700 kip) or 97.2 Mpa (14.1 ksi) while the control samples for this generation had an ultimate axial compression strength of 569 kN (128 kip) or 17.1 Mpa (2.5 ksi). This shows an increase in strength by a factor of approximately 5.5. Although the second generation columns failed at three times the load of the first generation columns, their behavior was very similar. The load-time history for Column H is a typical example of this generation and its ability to repeatedly release stress through failure of a circ and then build up to even a higher load (see Figure 33).

Figure 33 compares a 2nd generation column with the strongest 1st generation column (Column C) and a control specimen. This figure shows the large increase in strength and significant drop in load as each end circ failed. The next figure shows how the stress in these 2nd generation columns (Column H) is transferred as these circs failed (see Figure 34).

In Figure 33, gage 1 is labeled the “Top”, but is actually located on the 3rd circ down from the top of the column, while the middle circ is the 4th down (Middle of seven circs) and the 3rd gage is located on the circ just below the “Middle” gage. During the test, the first circ failed at 3.1 MN (700 kip) which correlates with the first drop in stress at 85 MPa (12 ksi). The next circ failed at 3.2 MN (720 kip) which correlates with the second drop in stress at 97 MPa (14 ksi). Gage 1 was closest to the end failure and consequently shows the highest strain value during the first circ failure while gage 3 shows the lowest strain value because it is the farthest from the failure. This plot shows how the strength of the circumferential reinforcement controls the ultimate strength of the column in compression.

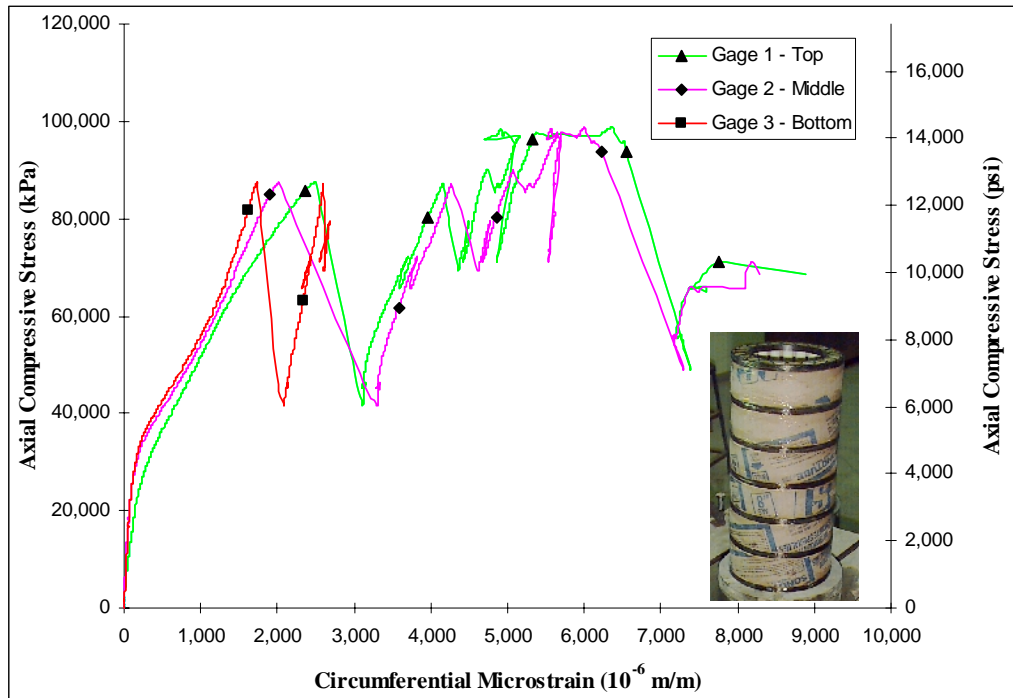
FIGURE 34 AXIAL STRESS VERSUS CIRCUMFERENTIAL STRAIN FOR 2ND GENERATION COLUMN

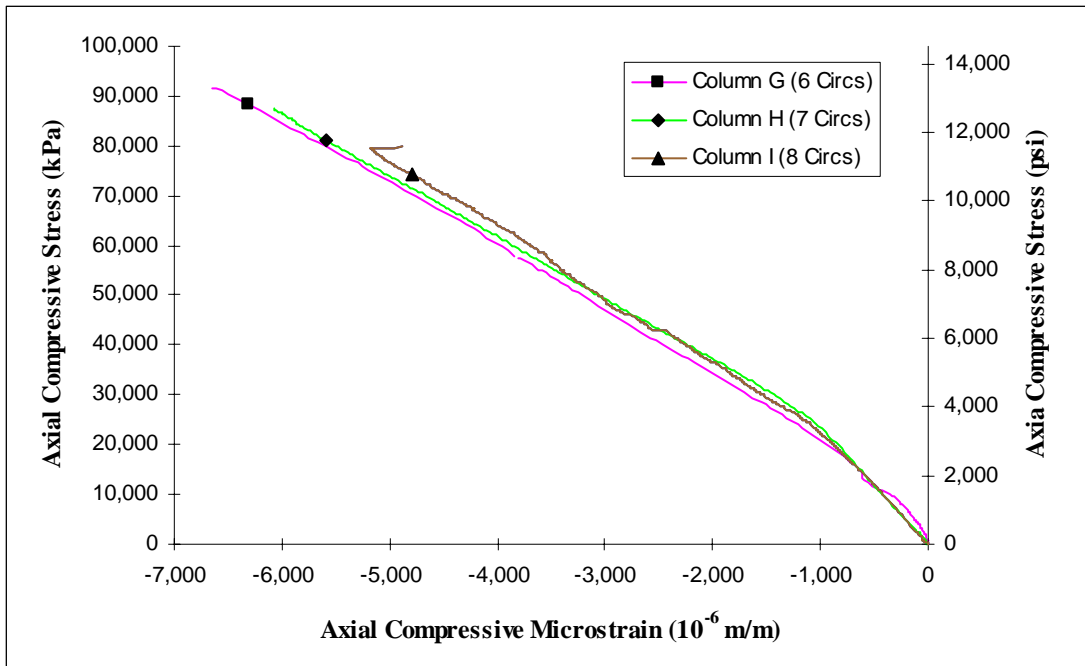
FIGURE 35 AXIAL COMPRESSIVE STRESS VERSUS STRAIN IN 2ND GEN. LONGITUDINAL REINFORCEMENT

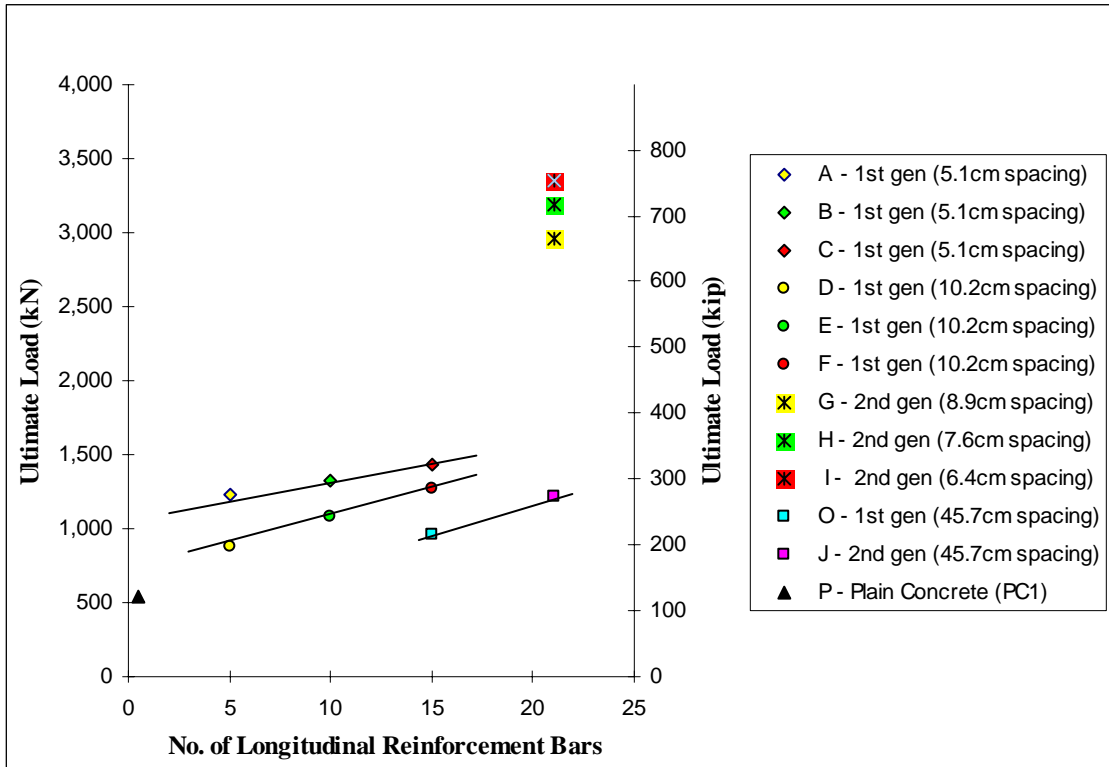
FIGURE 36 INFLUENCE OF LONGITUDINAL REINFORCEMENT ON 1ST AND 2ND GENERATION COLUMNS

A comparison was made between the different generations of circs by plotting the ultimate load and the number of longitudinal reinforcement bars (see Figure 36). The first and second generation columns suggest that the primary factor determining the failure of composite grid reinforced concrete columns is the strength of the circumferential reinforcement with a secondary factor being the longitudinal reinforcement. The fiberglass longis contain the concrete with their bending properties while the carbon circs contain the concrete with their tensile properties. This synergistic containment of the concrete prevents the column from expanding radially, delaying the primary mode of failure. A comparison between the first two generations of grid structures was also made by plotting the ultimate load and number of circumferential reinforcement (see Figure 37). Again, the results show that the strength of circumferential reinforcement controls the axial strength of the columns, while the spacing and percentage of circumferential containment only partially contributes to the strength. These observations were used to design the 3rd generation columns.

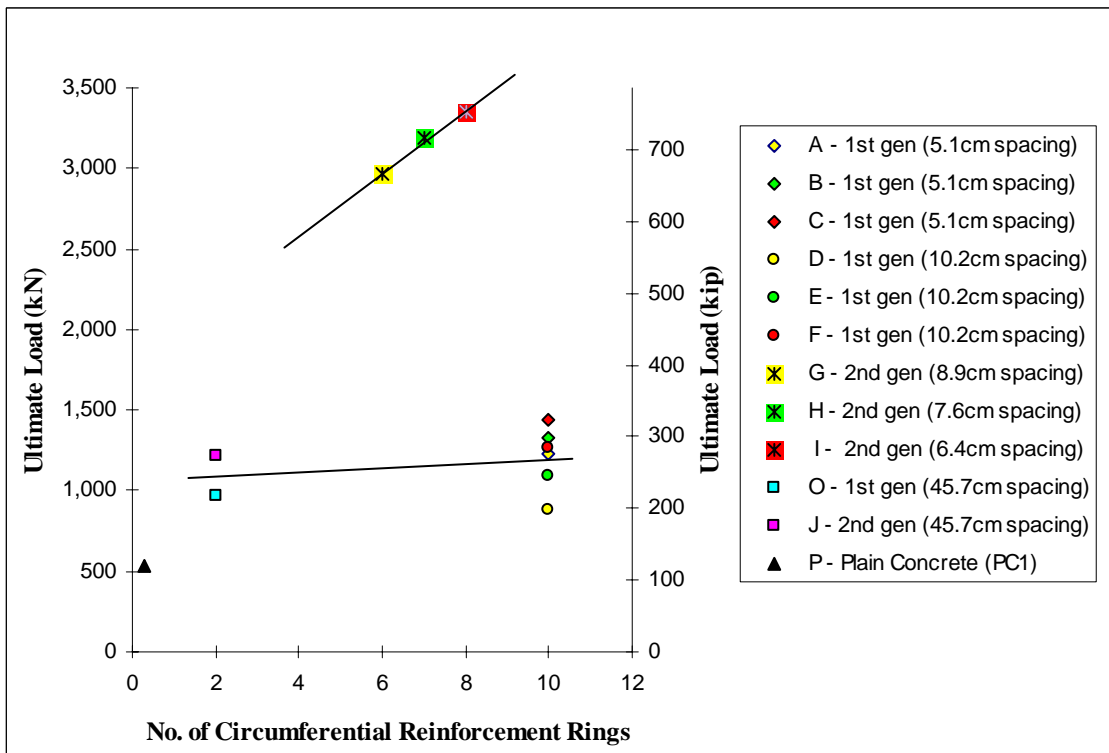
FIGURE 37 INFLUENCE OF CIRCUMFERENTIAL REINFORCEMENT ON 1ST AND 2ND GENERATION COLUMNS

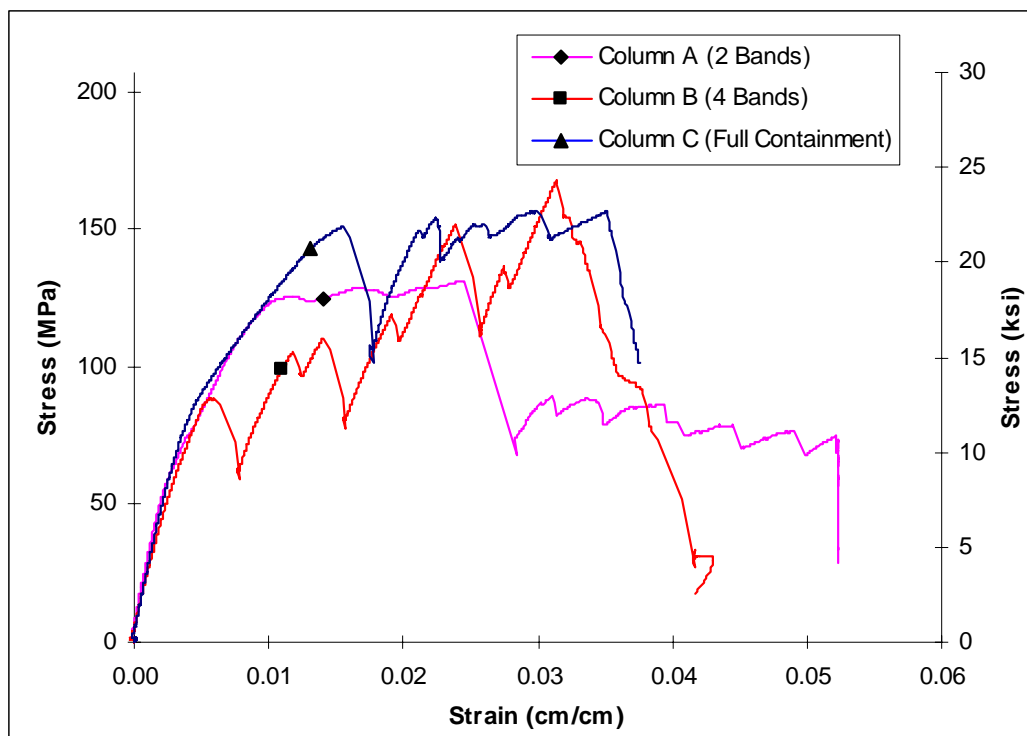
FIGURE 38 STRESS VERSUS STRAIN FOR 3RD GENERATION WITHOUT STEEL ENDCAPS

The third generation columns failed in a similar manner as the 1st and 2nd generation columns; however a much higher compressive load was reached by focusing on principles learned from previous testing. Steel endcaps were used in order to prevent end failure and focus on containment. Two columns of the same geometry were constructed; one was tested with steel endcaps and one without (see Figure 38 and Figure 39).

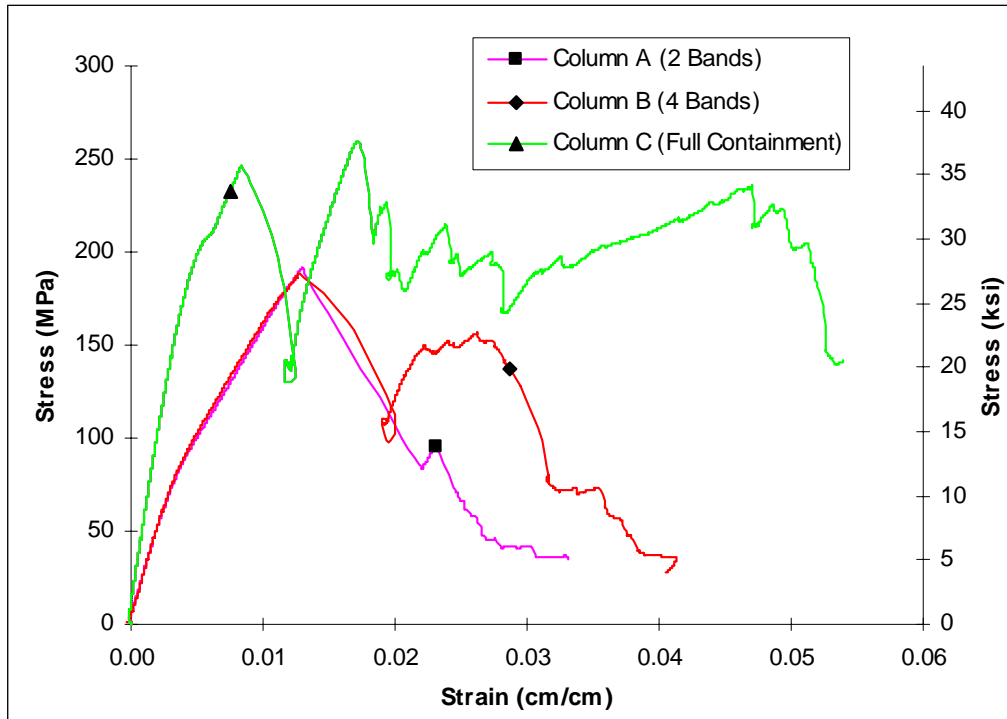
FIGURE 39 STRESS VERSUS STRAIN FOR 3RD GENERATION WITH STEEL ENDCAPS

Even without the steel endcaps these third generation columns reached ultimate loads around 3.6 MN (800 kip) or 150 Mpa (22 ksi). This is five times the strength of the control specimens and almost three times the strength of the 1st generation grid structures. Column C with full Containment showed the highest strength at 3,665 kN (824 kip) while Column A with only partial containment at the ends of the column (40% containment) failed at 3,196 kN (720 kip). Column B with 80% containment failed at 3,523 kN (792 kip). There was not a large difference in ultimate strength between these columns; however Figure 39 shows the effect of mitigating end failure.

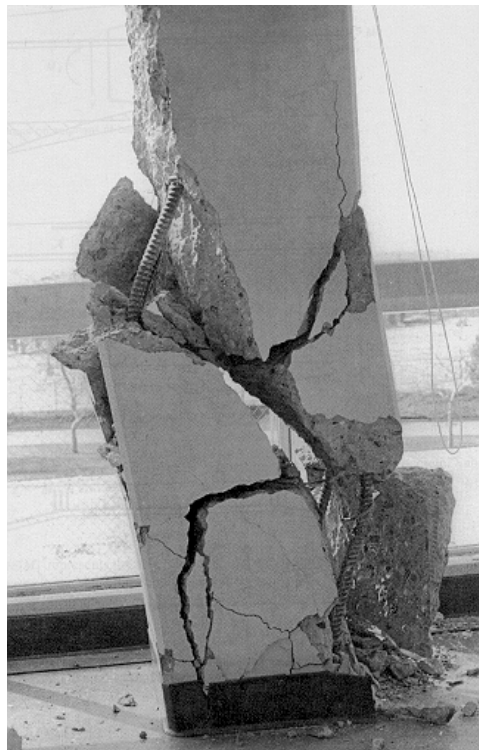
FIGURE 40 PHOTOGRAPH OF SHEAR FAILURE IN REINFORCED COLUMN

Plain concrete columns typically fail due to shear which is evident in a 45° to 60° angle crack after failure. Reinforced concrete columns can be subjected to shear plus axial tensile or compressive forces due to such causes as gravity load effects in inclined members, stresses resulting from restrained shrinkage, wind and seismic forces [MacGregor, 1997]. Figure 40 shows a tied column that failed in shear during the 1971 San Fernando, California Earthquake.

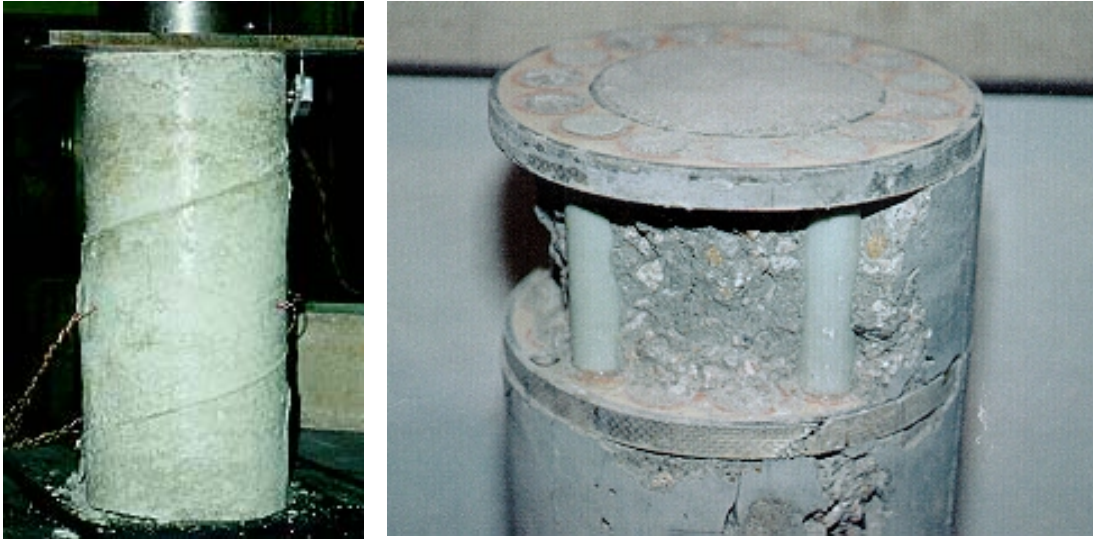
FIGURE 41 PRELIMINARY TEST AND END FAILURE FOR CONFIGURATION WITH 6 CIRCS, 5 LONGIS

For the 1st generation columns, failure generally initiated at one end of the column. When the preliminary tests were performed, the concrete between the circumferential reinforcement could be seen “bulging” due to lack of containment (see left photo in Figure 41).

The concrete crumbled locally, the end circ slid down the longis, and the ends of the pultruded longis exhibited brooming. Soon after this, one of the end circs would fail which would further broom out the longis and increase the area over which the load was applied. Tests were also performed on this same grid structure at Hong Kong University where these columns failed in a similar manner at one end of the column (see the right photograph in Figure 41).

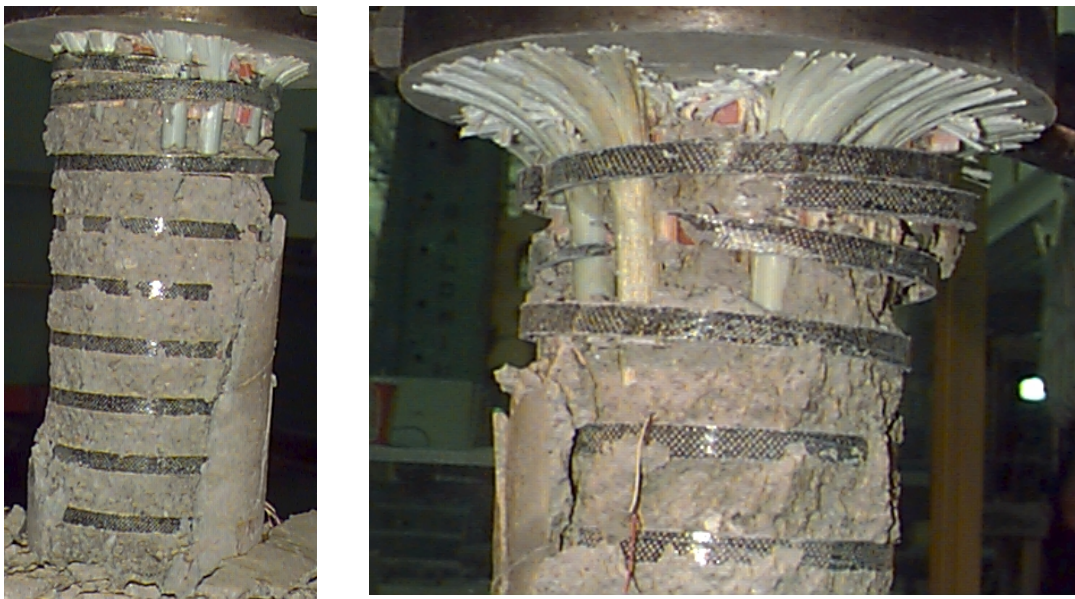
FIGURE 43 PHOTOGRAPHS OF COLUMN B IN AXIAL COMPRESSION, SHOWING BROOMING OF THE LONGIS

Column B showed a similar failure with initial spalling of the outer concrete and then a dramatic end failure which initiated at one end of the column and resulted in brooming of the longis as the individual end circs failed (see Figure 43).

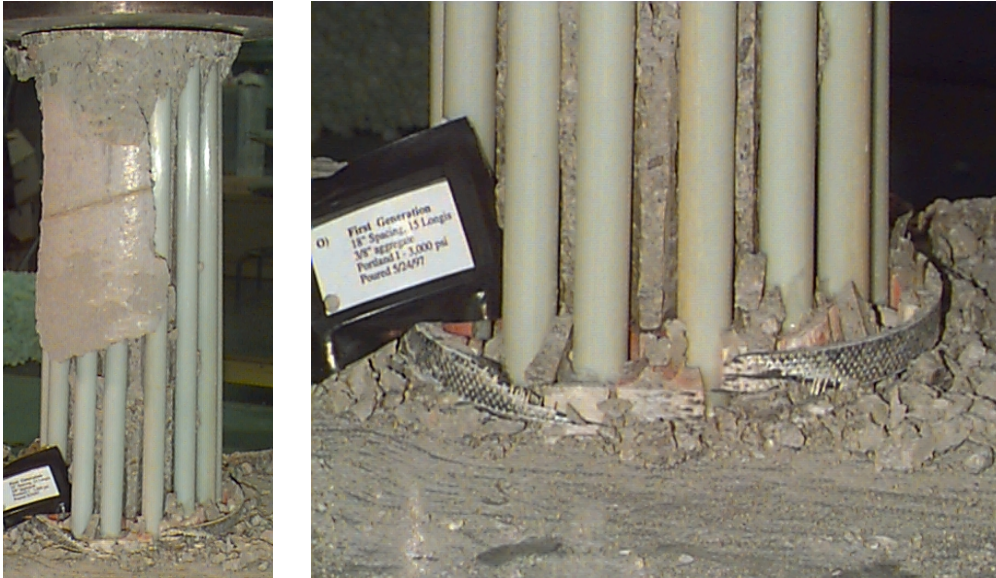
FIGURE 45 PHOTOGRAPHS OF COLUMN O, SHOWING END CIRC FAILURE BEFORE BUCKLING OF LONGIS

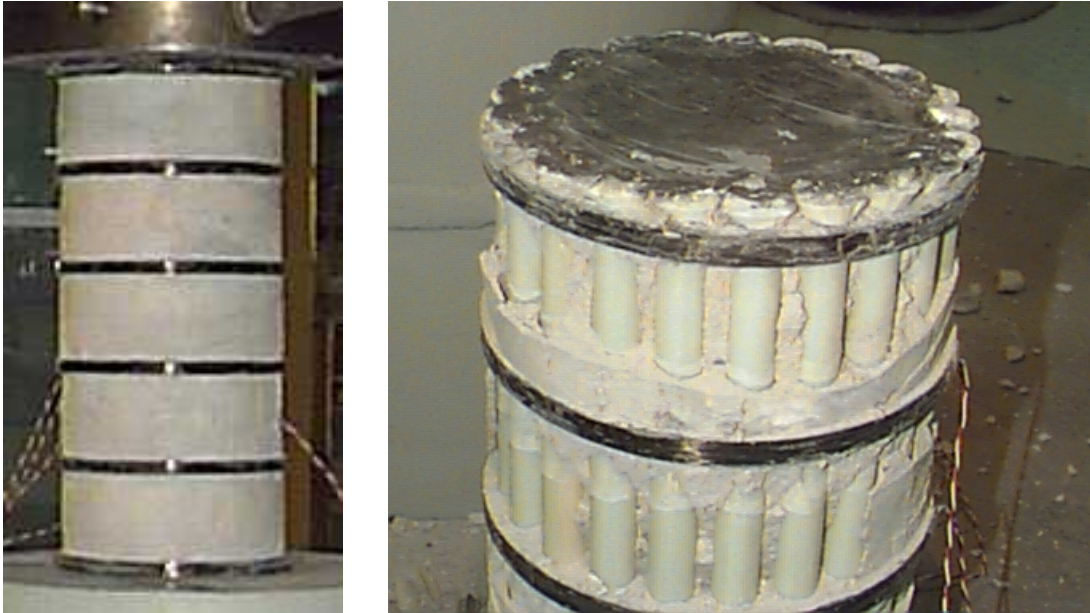
FIGURE 49 PHOTOGRAPHS OF COLUMN G IN AXIAL COMPRESSION, END FAILURE SHOWN
