CONCRETE COLUMNS REINFORCED WITH ADVANCED COMPOSITE GRID STRUCTURES

A Thesis

Department of Civil and Environmental Engineering

Brigham Young University

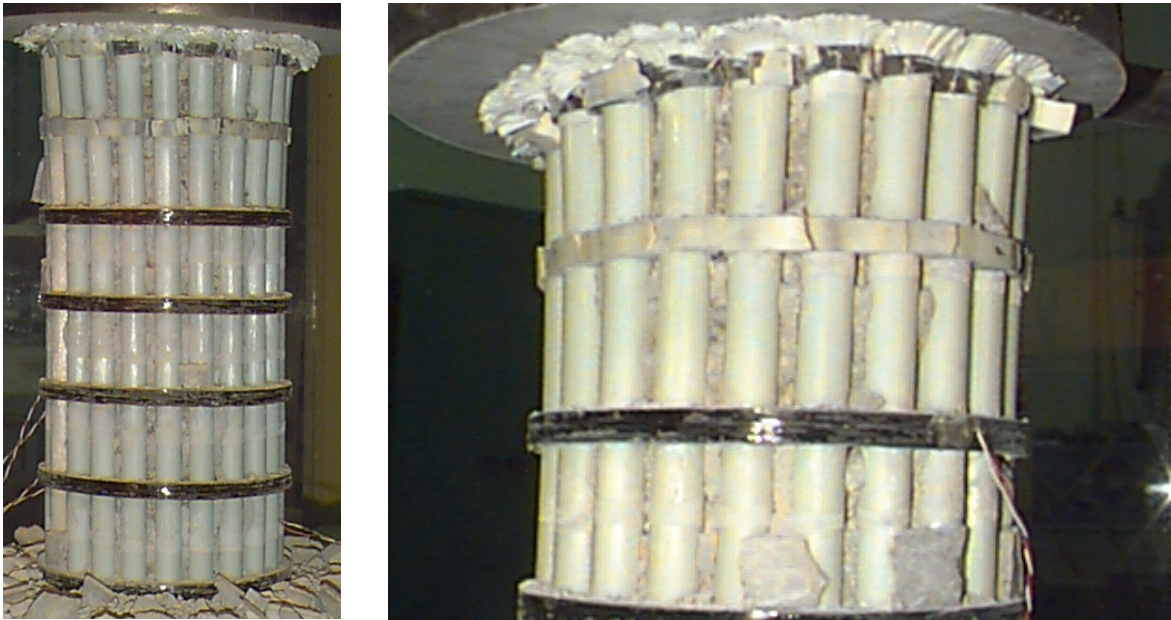
FIGURE 50 PHOTOGRAPHS OF COLUMN H IN AXIAL COMPRESSION, BROOMING OF LONGIS SHOWN

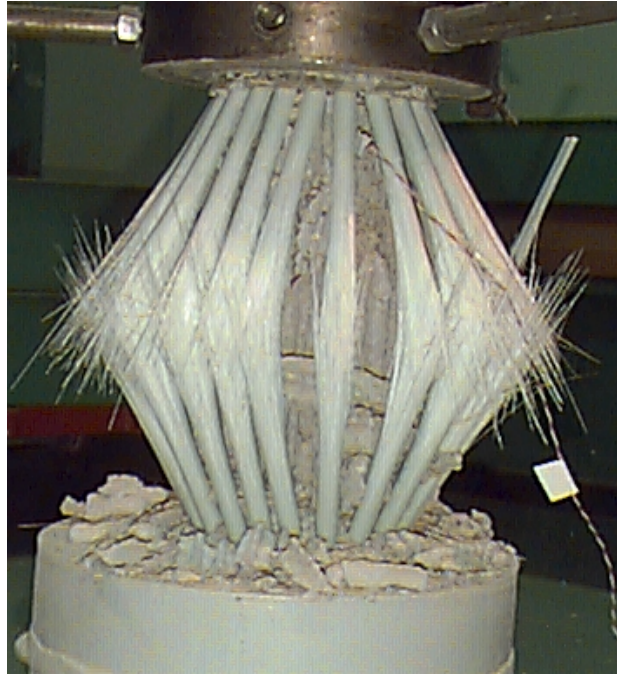
FIGURE 52 PHOTOGRAPH OF COLUMN J IN AXIAL COMPRESSION, BUCKLING OF THE LONGS

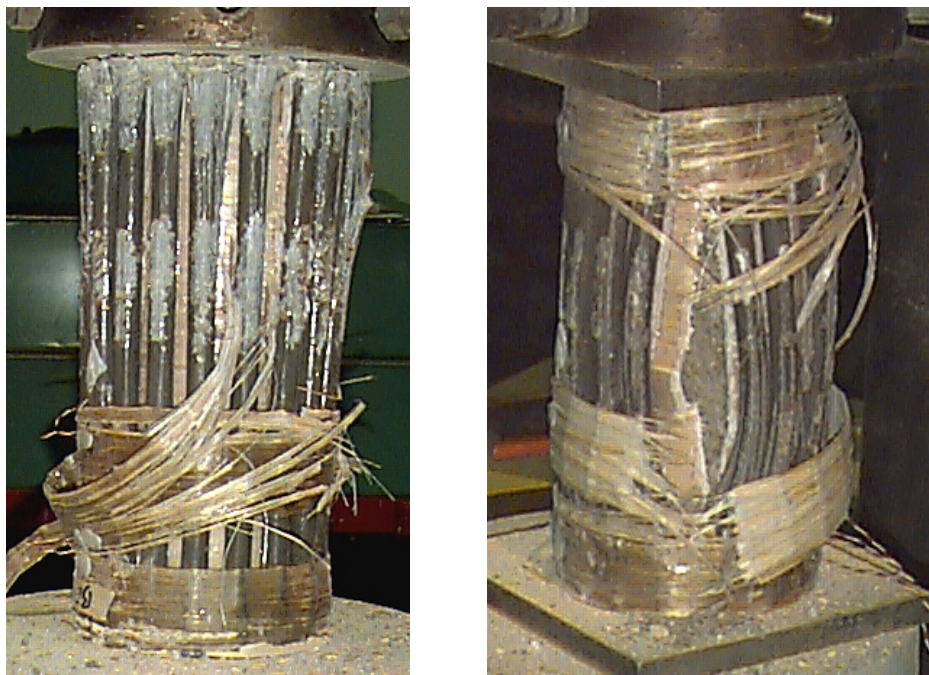
FIGURE 54 COLUMN B IN AXIAL COMPRESSION, SHOWING FAILURE OF 4" END WRAPS

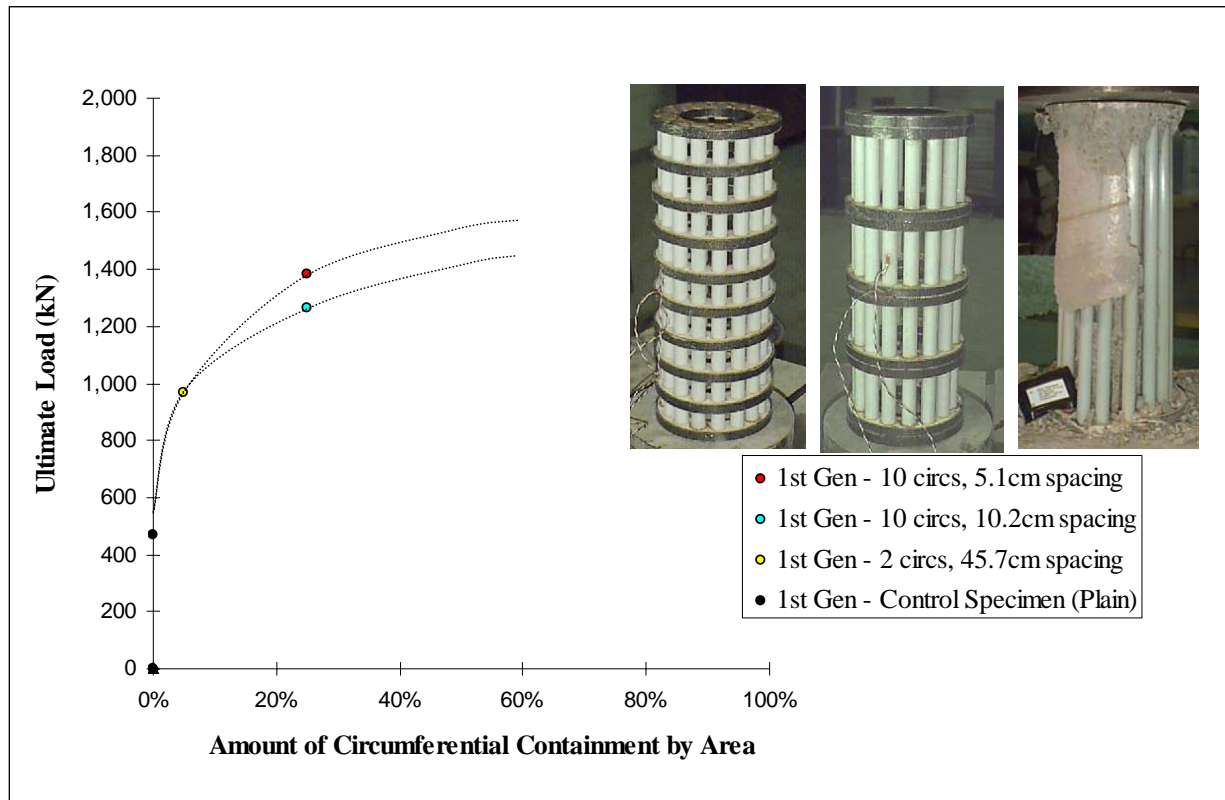
FIGURE 57 COMPARISON OF 1ST GENERATION COLUMNS IN AXIAL COMPRESSION BY AMOUNT OF CONTAINMENT

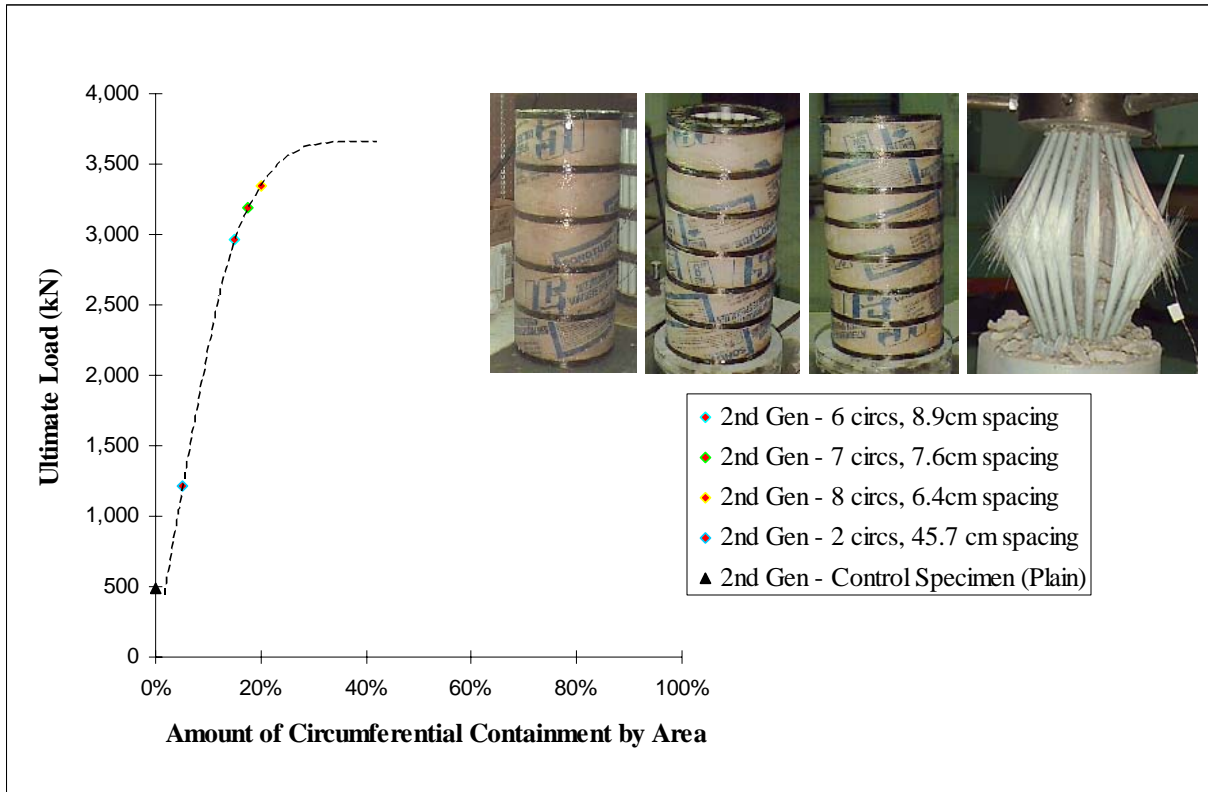
FIGURE 58 COMPARISON OF 2ND GENERATION COLUMNS IN AXIAL COMPRESSION BY AMOUNT OF CONTAINMENT

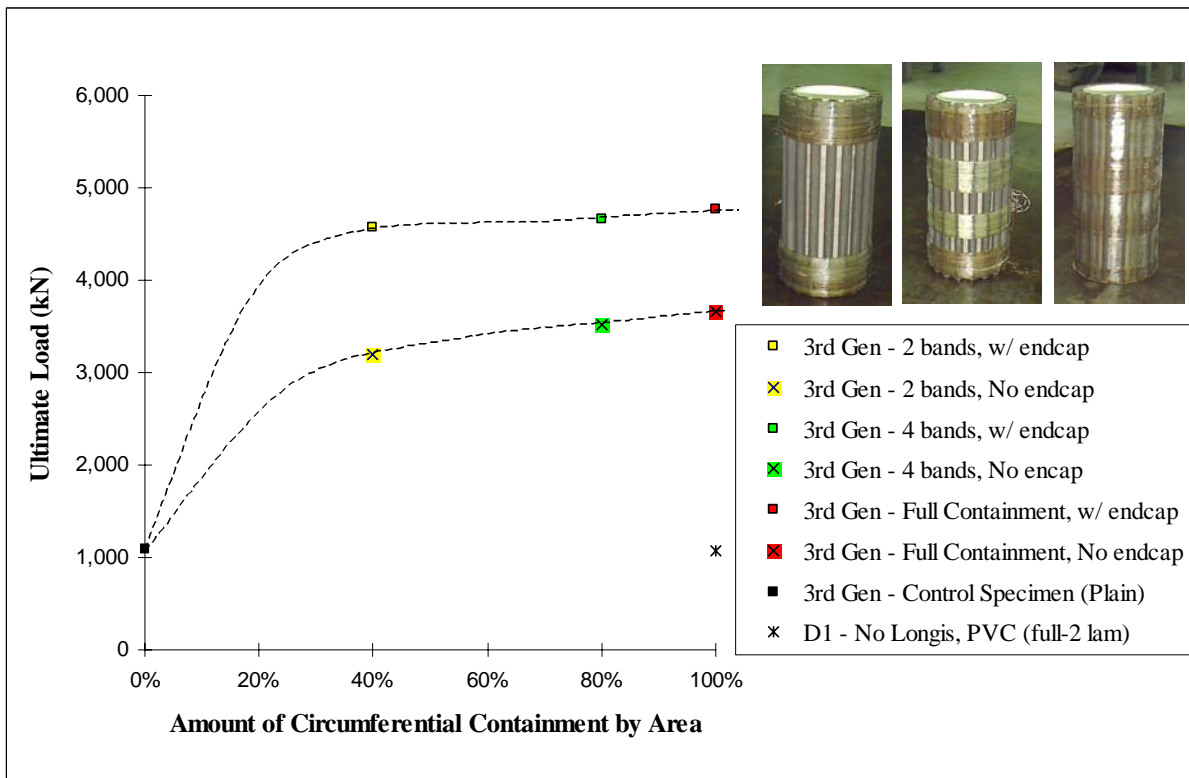
FIGURE 59 COMPARISON OF 3RD GENERATION COLUMNS IN AXIAL COMPRESSION BY AMOUNT OF CONTAINMENT

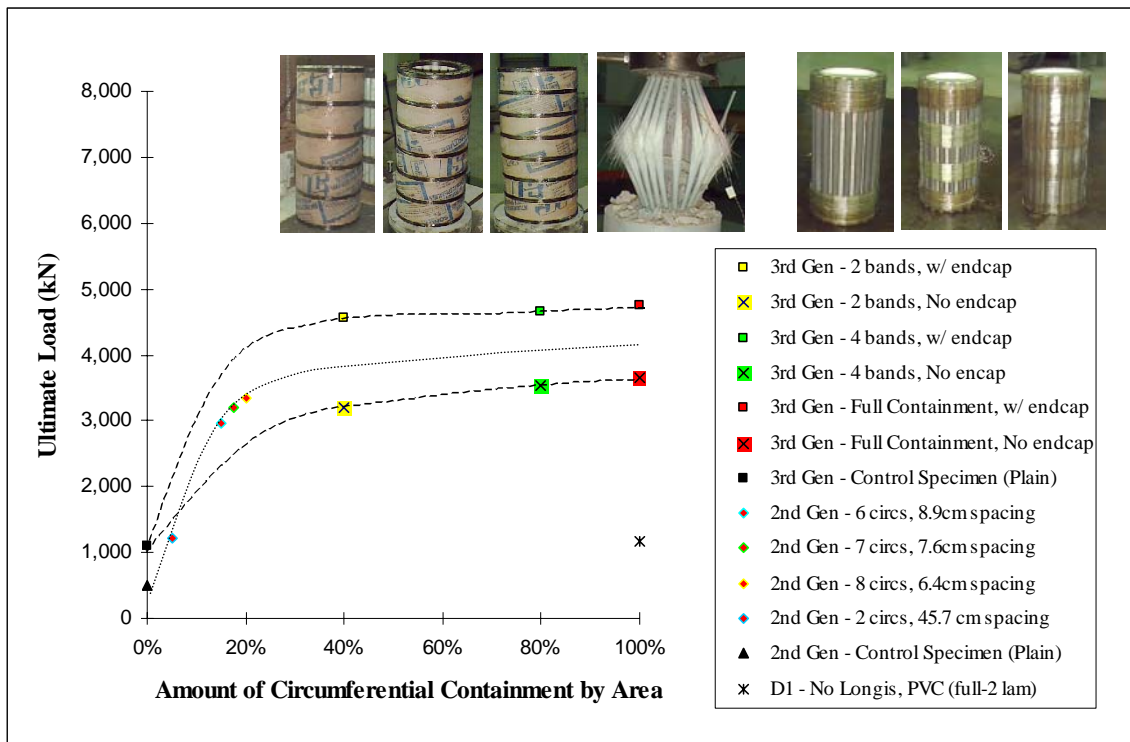
FIGURE 60 COMPARISON OF 2ND AND 3RD GENERATION COLUMNS BY AMOUNT OF CONTAINMENT

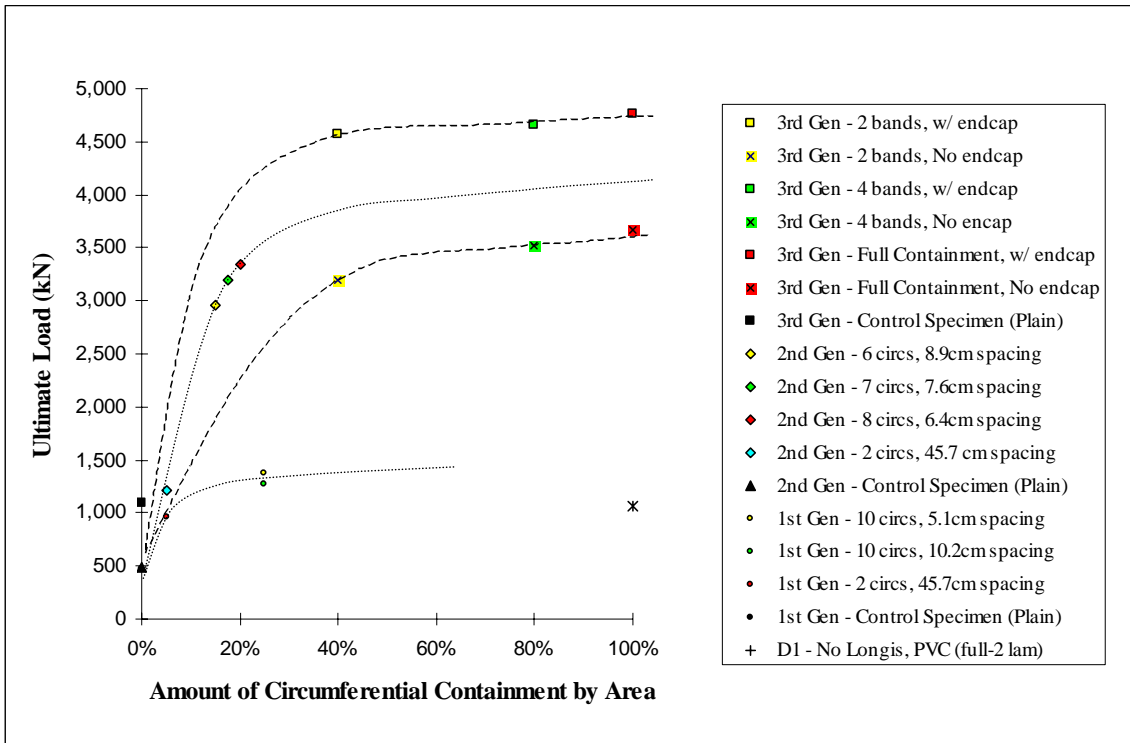
FIGURE 61 COMPARISON BETWEEN 1ST, 2ND, AND 3RD GENERATION COLUMNS BY AMOUNT OF CONTAINMENT

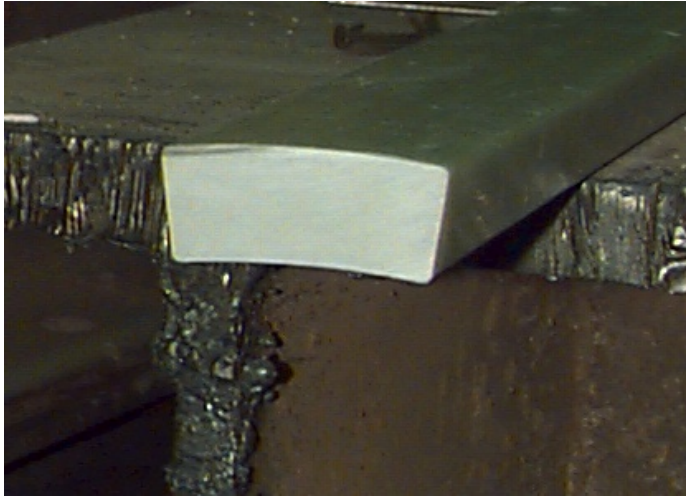
FIGURE 62 PHOTOGRAPH OF FAN-SHAPED LONGI FOR 4TH GENERATION COLUMNS

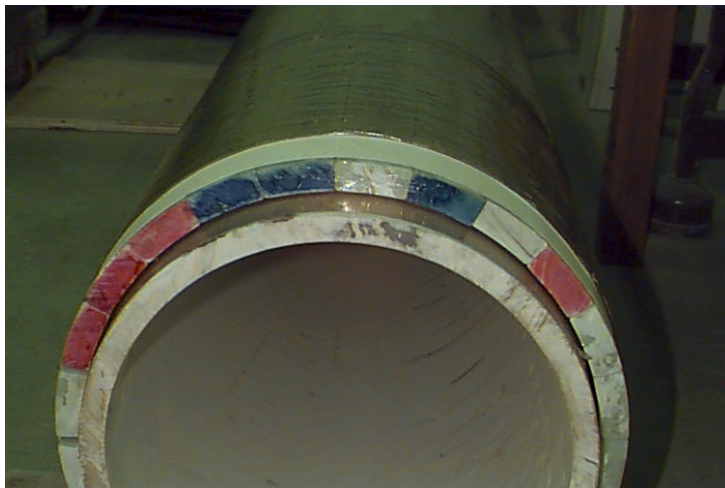
FIGURE 63 PHOTOGRAPH OF FAN-SHAPED LONGIS ON MANDREL

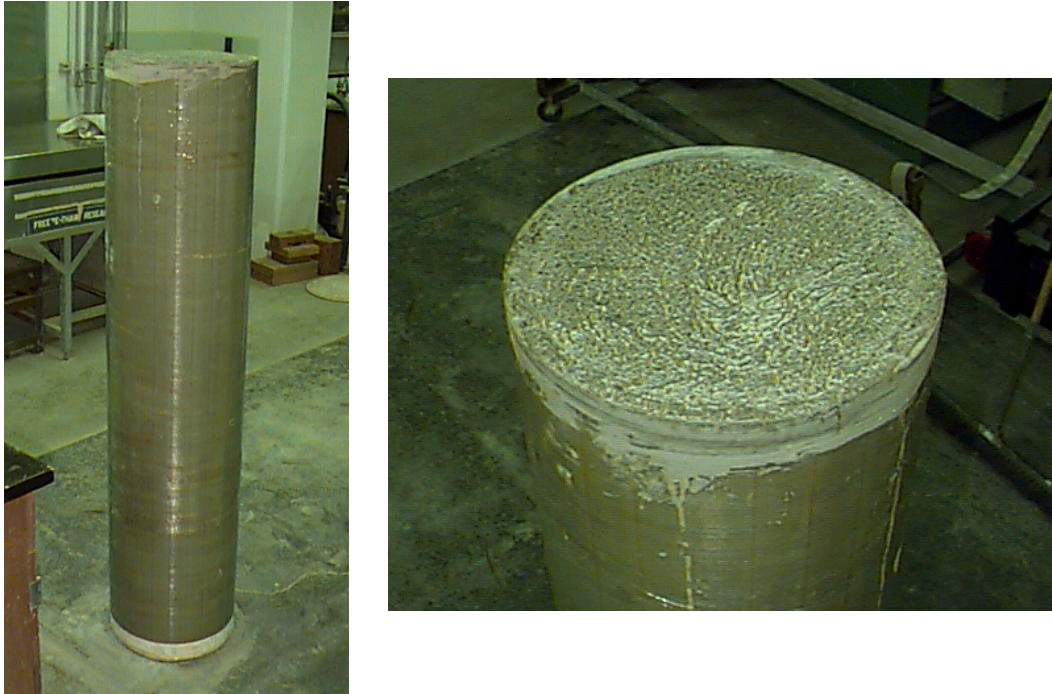
FIGURE 64 PHOTOGRAPHS OF 4TH GENERATION COLUMN FILLED WITH HIGH STRENGTH CONCRETE
